Lake Nyos Dam Assessment

Cameroon, September 2005

Joint UNEP/OCHA Environment Unit

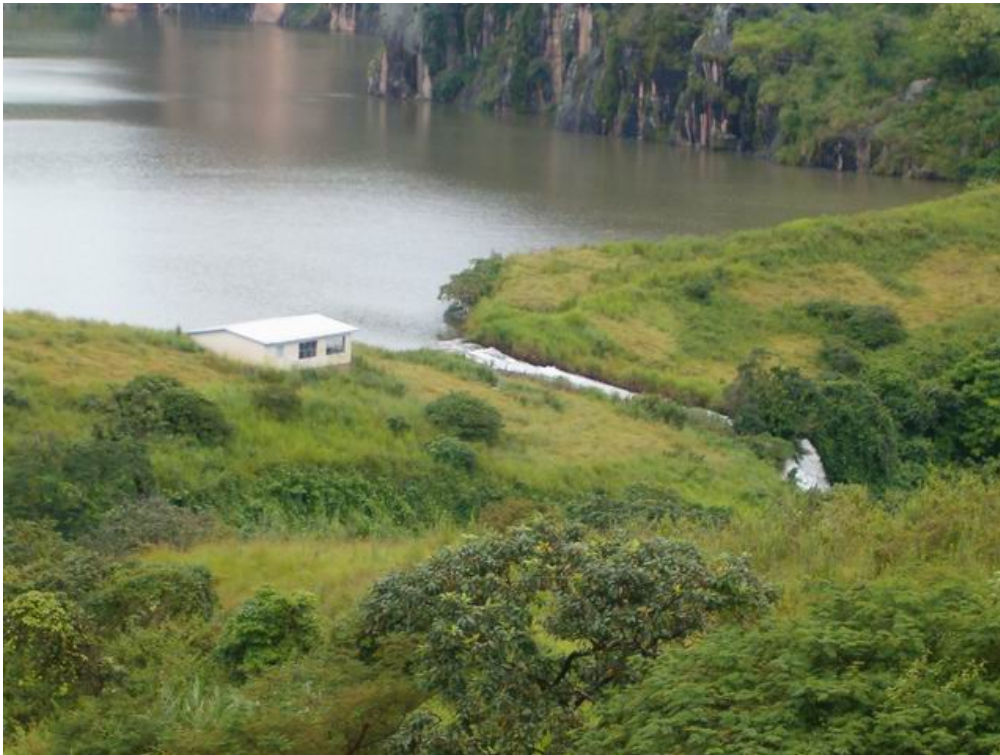
The dam at the northern end of the lake has obviously receded since its formation some 400 years ago. The dam consists of (pyroclastic layers of) gravel, rock and mountain soil. The area surrounding the lake shows traces of nearly vertical landslides and rock falls. In addition, downstream of the dam old and recent landslides can be identified. There are even indications of landslides will occur at the section of the dam just east of the spillway. It is evident that landslides will occur in the coming years thereby seriously endangering the overall stability of the dam. Leakage is visible through the soil mass.

During the rainy season the lake drains over the spillway into the Northern dam. At the downstream end, the water runs over a cliff in a 40-meter high waterfall. At the spillway the dam at its most narrow point and below the spillway large boulders indicate earlier collapses of the front, causing the waterfall to recede. The chances for a breach are increased by erosion at the top, erosion at its base, hydrogeochemical erosion and piping. Yet, the dam is kept between the adjacent soil bodies and derives parts of its stability from these. Breaching of the spillway would always include failure of part of these soil bodies as well.

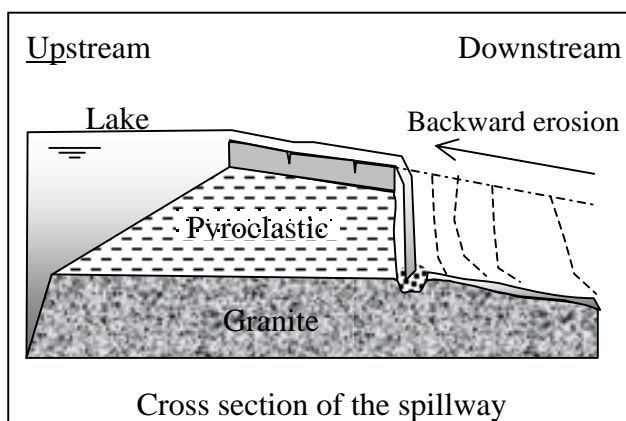
An on-site inspection of the lake and its spillway took place on 25 September. The spill was inspected from both its up- and downstream sides. Observations made during the inspection clearly showed the displacement of large boulders. In addition, deep cracks and potholes on top of the spillway showed the impacts of ongoing erosion. This erosion causes a regression of the waterfall toward the lake. Thereby the dam becomes narrower over time. This is not only at the spillway, but the whole dam has eroded in this way.

An important finding was that not the spillway, but the adjacent soil structures, appear to be the weakest spot in the dam area. The dense surface vegetation indicates an extremely humid soil, which further reduces the strength of the spillway. Also the roots of trees create little waterways, weakening the structure further. Caves in the soil structures at the lakeside were also detected leading to the conclusion that the stability of the spillway is affected from both sides and the soil structures, which hold the dam together, are far more likely to collapse first. Remaining questions include when a new rock fall will occur and if so, at which location this will take place. These questions will determine ultimately the strength of the dam.
